Manhole Inspection Summary

Manhole # S25CC_010MH

Location Address: **1130 SMITHSON ST**

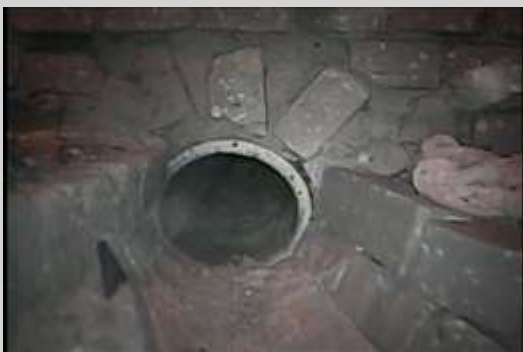
9 O'Clock Inflow

Pipe In @ 9 O'Clock

Pipe Height: **6** (in.) Rod and Bar (Angled)

Pipe Material: **Clay** ☐ Pipe Lined

Infiltration: **None** Pipe Seal Cond: **Sound**
